# NAGA and AGL Sustainable Public Lighting Initiative

## Demonstration Project

Final Report  
**September 2007**

**This report provides information on trials that were carried out by AGL in the Northern Alliance for Greenhouse Action (NAGA) Council areas in the North of Melbourne from 2004 to 2007.**

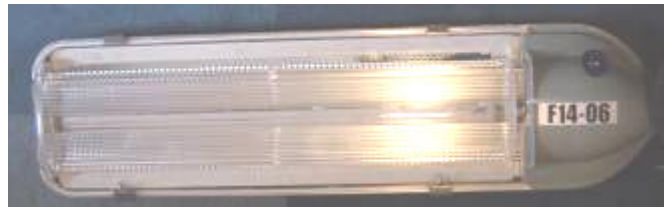
*2x14W T5*

Based on the results of these trials we recommend the use of the T5 as a standard direct replacement for the 80W Mercury Vapour. The T5 luminaire has an International Protection (IP) rating similar to other accepted luminaires. Maintenance is slightly increased which results in increased maintenance cost, because of two lamps and electronic control gear that may require periodic replacement.

Benefits include better uniformity of light across and along the street, better colour rendering and visibility, best current technology in terms energy performance, less lumen depreciation and lamp failure rate.

Based on the results of these trials we recommend the use of the T5 as a standard direct replacement for the 80W Mercury Vapour. The T5 luminaire has an International Protection (IP) rating similar to other accepted luminaires. Maintenance is slightly increased which results in increased maintenance cost, because of two lamps and electronic control gear that may require periodic replacement.

Although unit cost is slightly increased in terms of maintenance and purchase the benefits of better uniformity of light across and along the street, better colour rendering and visibility, best current technology in terms energy performance, less lumen depreciation and lamp failure rate far outweigh the costs.

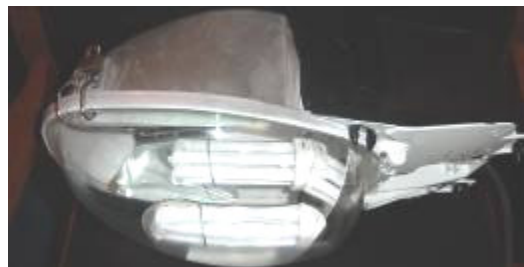
*42W CFL*

Based on the results of these trials we recommend the use of the 42W CFL as a direct replacement for the 80W MV only where 2x14W T5 cannot be used (e.g. some decorative streetlights).

Based on the results of these trials we recommend the use of the 42W CFL as a direct replacement for the 80W MV only where 2x14W T5 cannot be used (e.g. some decorative streetlights).

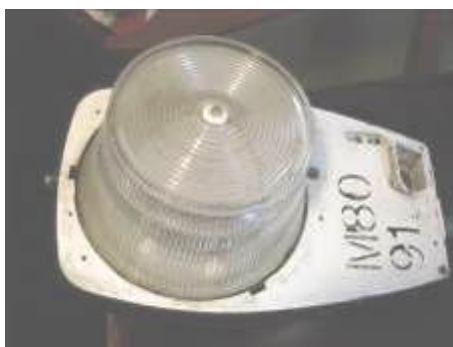
*One of the lights that were replaced,  
a Sylvania 80W MV B2224, manufactured in 1991*

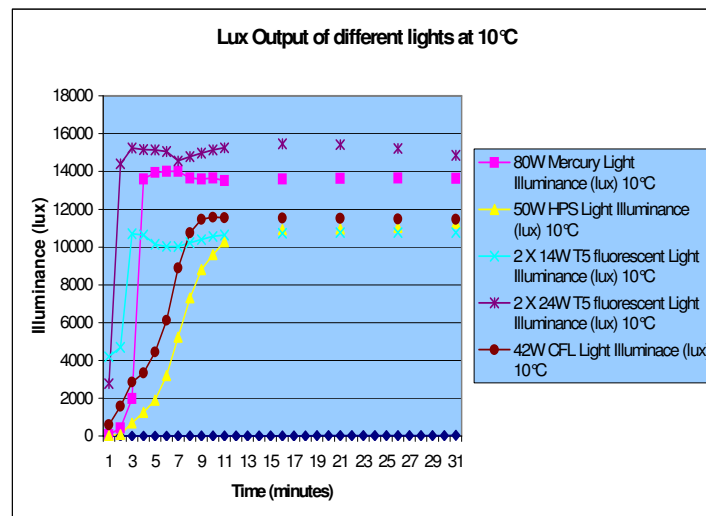
The results of the SPLI study quoted in the voltage section above are again replicated below to illustrate the effects of an ambient temperature of 10°C (typical for normal starting time of a Melbourne winters night) on the starting for each of the five luminaires under consideration in that study.

As this graph indicates, once the initial starting period is over and the luminaires reach a steady state temperature condition, there is very little between them.

Even with ambient temperatures down to 5°C there was little effect on the light output. The critical factor in this situation is any possible degree of air and dust leakage through the seals of the luminaire. If there is no leakage then the luminaire chamber then it appears to maintain its steady state temperature. This is dependent on the International Protection (IP rating) of the luminaire in question.

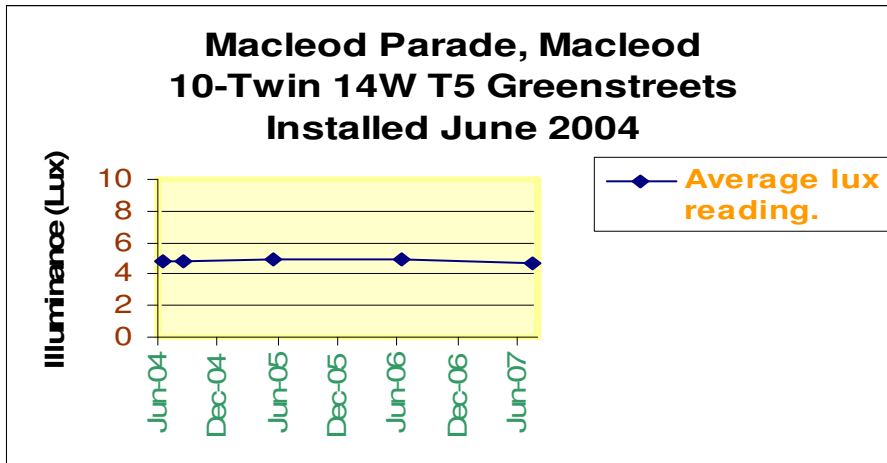
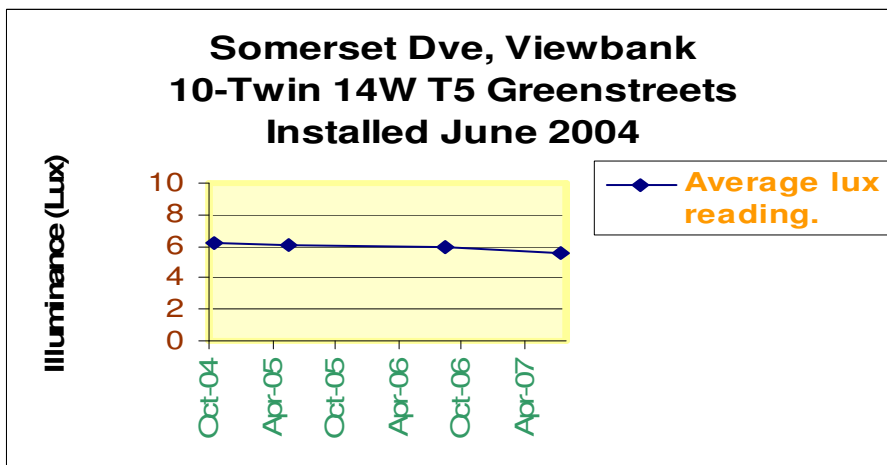
### Banyule City Council

The following section details the change in illuminance in each street over the trial period. It is worth noting that the figures in-field will only approximate laboratory tests because of the inability to avoid some variation due to natural phenomenon such as temperature variability, cloud cover etc. The illuminance figures are an average of the illuminance under each light for a given street. Specific graphs for each street in the trial are shown in **Appendix.2: In-field Illuminance Records**.

The results of the in-field illuminance trial demonstrates that the 2x14W T5 fluorescent and 50W High Pressure Sodium Luminaires are operating close to the figure of 10% depreciation provided by lamp manufacturers.

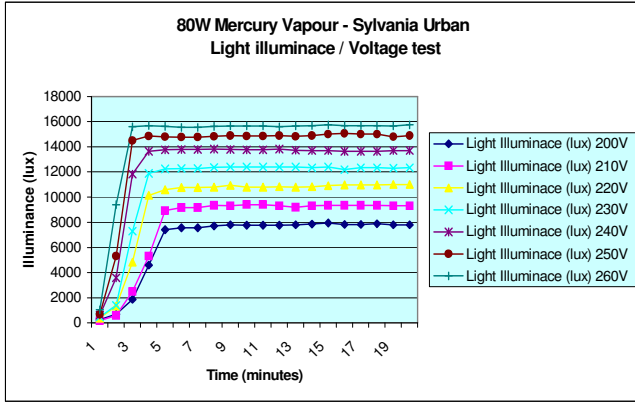
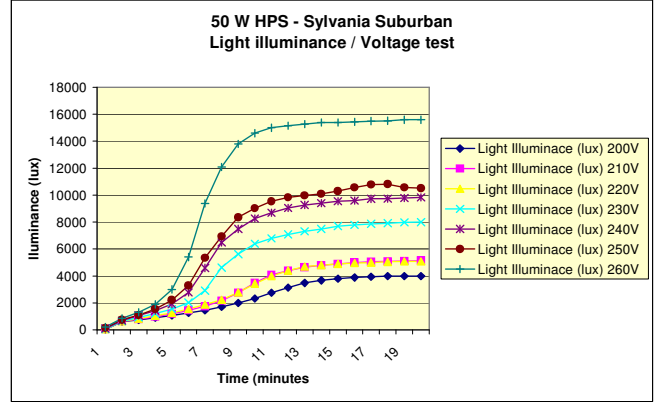
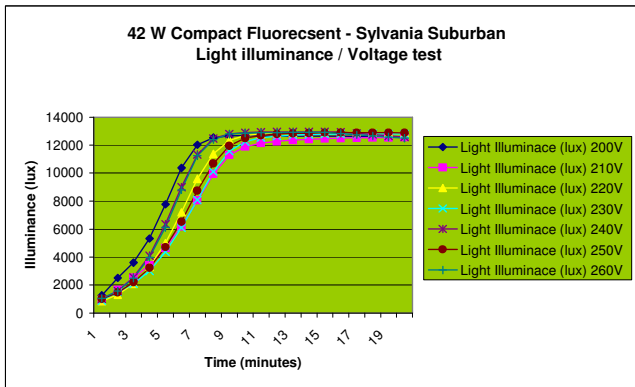
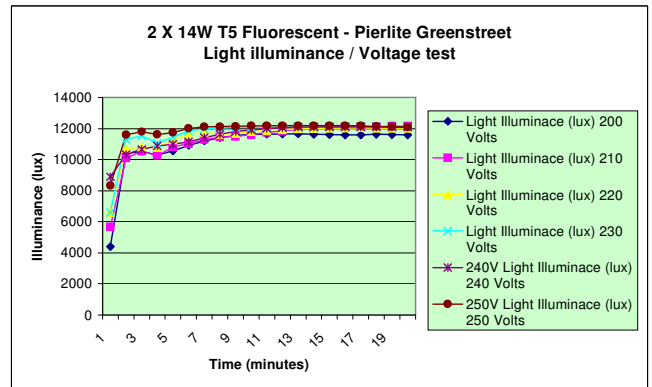
# APPENDIX 4. Effects of Voltage Variation On Light Output

The only variable was the supply voltage which was varied in 10 volt steps from 200V to 260V. Light output readings were taken at one minute intervals from initial start up time to 30 minutes, and the test results are shown below.

The graphs shown in **Appendix 4. Effect of Voltage Variation on Light Output** demonstrate that lights with ‘electronic control gear’ such as the T5 and CFL luminaires are largely unaffected by voltage variation. Whereas lights with iron core ballasts, such as the 80W MV and the 50W HPS are greatly affected.

According to the testing program the 80W MV varied in light output by around 30% between 220V and 260V and the 50W HPS by around 60-70%.
